**TMS320C6712, TMS320C6712C, TMS320C6712D**  
**Digital Signal Processors**  
**Silicon Errata**

**C6712 Silicon Revisions 1.0, 1.2, 1.3**

**C6712C Silicon Revision 1.1**

**C6712D Silicon Revision 2.0**

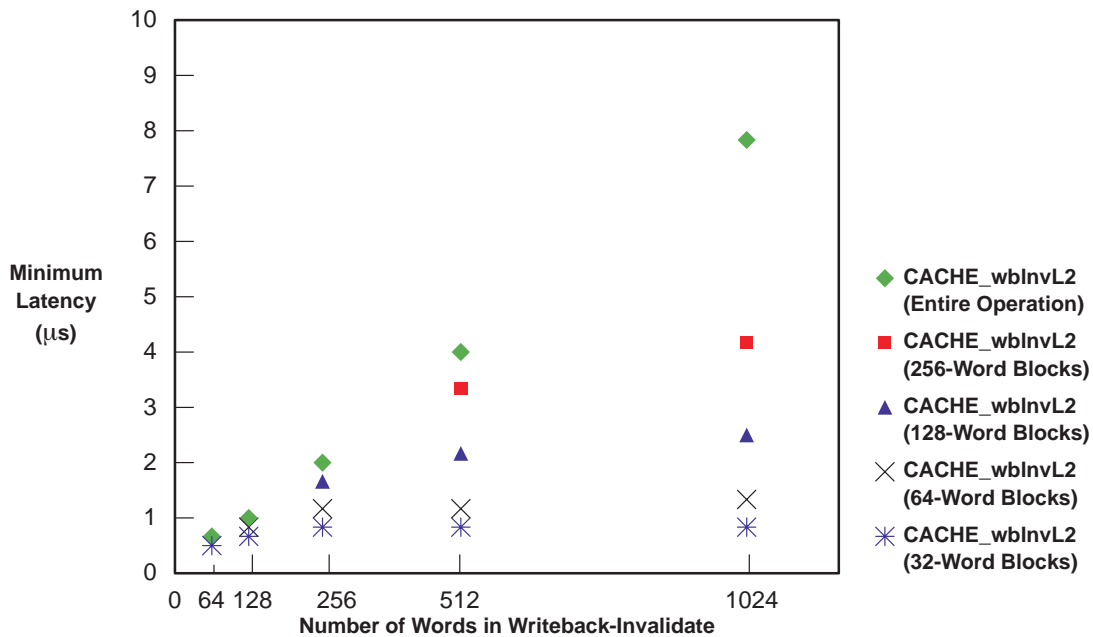
**Figure 2. Minimum Required Latency Between McBSP Events for a Successful Transfer with Concurrent L2 Writeback-Invalidates at 200-MHz CPU and 50-MHz EMIF, Using Entire Operations and Block Breakdown**

For example, if the CPU is running at 200 MHz with a 50-MHz EMIF and you have a McBSP hard real-time deadline of 5  $\mu$ s, Figure 2 shows that a 1024-word L2 writeback-invalidate may cause data loss since back-to-back McBSP events can only be serviced at  $\sim 8$   $\mu$ s. By breaking down the L2 writeback-invalidate into 256-word blocks, you can then meet the 5- $\mu$ s McBSP deadline. In other words, when performing a 1024-word L2 writeback-invalidate operation with the CPU and EMIF conditions cited above, the McBSP events can be serviced in  $\sim 8$   $\mu$ s for the entire operation (one whole block), in  $\sim 4$   $\mu$ s when breaking it into 256-word blocks, in  $\sim 2.5$   $\mu$ s when breaking it into 128-word blocks, etc.

To avoid cache operations blocking other time-sensitive EDMA accesses, observe the following guidelines:

1. Avoid placing real-time data in EMIF address range. Instead, real-time data should be placed in the L2 address range.
2. If data must be placed in the EMIF address range:
  - Avoid global cache operations in favor of block-based cache operations.
  - Block-based cache operations should be submitted in small blocks, such that the total amount of time that the EMIF is blocked is less than the amount of time between serial samples.

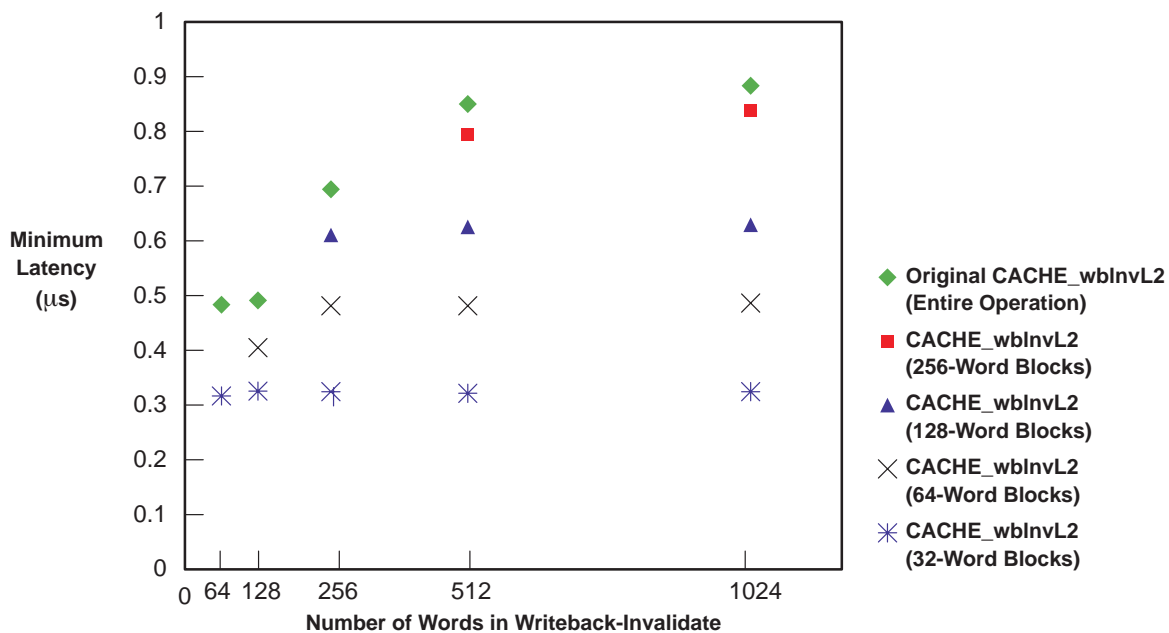
**Figure 3. Minimum Required Latency Between McBSP Events for a Successful Transfer With Concurrent Writeback-Invalidates at 225-MHz CPU and 100-MHz EMIF, Using Entire Operations and Block Breakdown**

When the CPU is set to 225 MHz and the EMIF is set to 100 MHz, breaking down the cache operations will still improve the block-out problem. Figure 3 shows the improvement in the McBSP's performance with this frequency ratio.

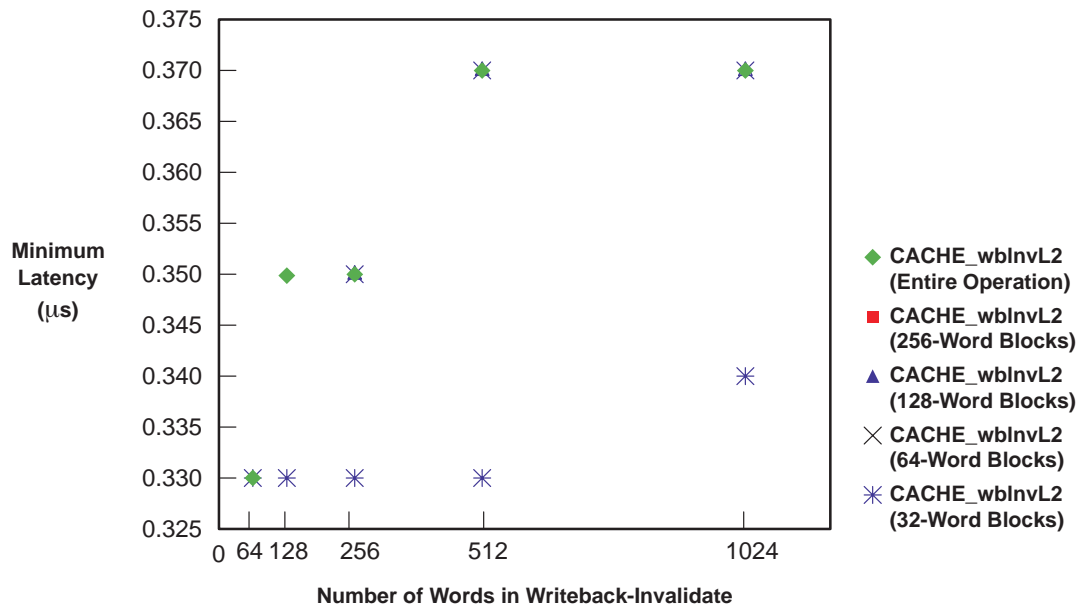
**Figure 4. Minimum Required Latency Between McBSP Events for a Successful Transfer With Concurrent Writeback-Invalidates at 150-MHz CPU and 100-MHz EMIF, Using Entire Operations and Block Breakdown**

When the CPU is set to 150 MHz and the EMIF is set to 100 MHz, there is virtually no benefit from breaking down the coherency cache operations. Figure 4 shows the McBSP’s performance with this frequency ratio.

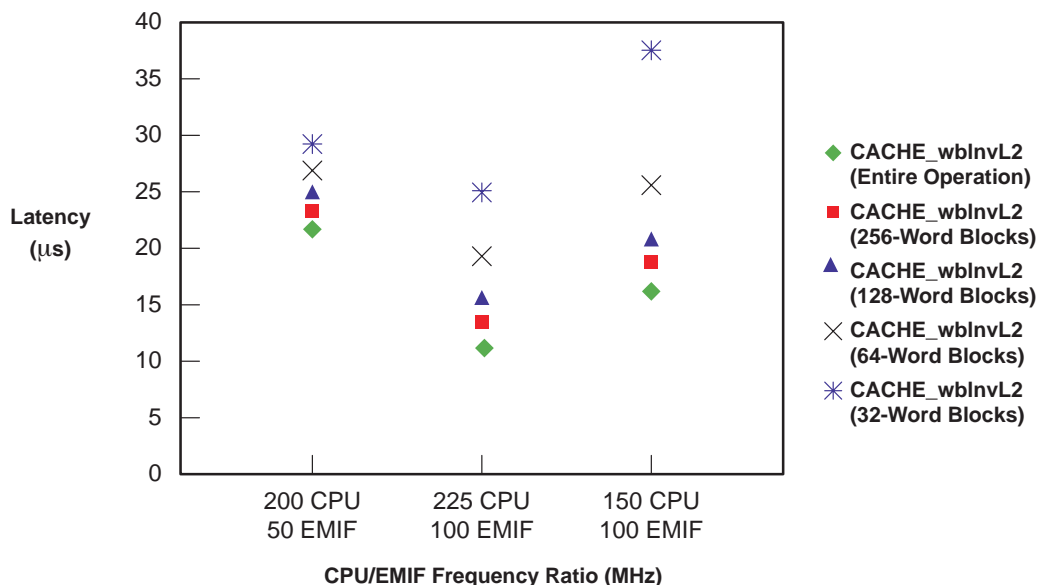
**Figure 5. 1024-Word L2 Writeback-Invalidate Performance at Various Frequency Ratios With Old and New CACHE-wbInvL2()**

Breaking down the cache operations into smaller blocks takes longer to complete than performing the entire cache function as one large block. Figure 5 shows how much extra overhead is incurred by breaking down an L2 writeback-invalidate operation to transfer 1024 words with different sized blocks and at various frequency ratios. Notice that for the 200-MHz CPU and the 50-MHz EMIF frequency ratio, where the new functions are most critical for peripherals such as the McBSP, the least overhead is incurred.

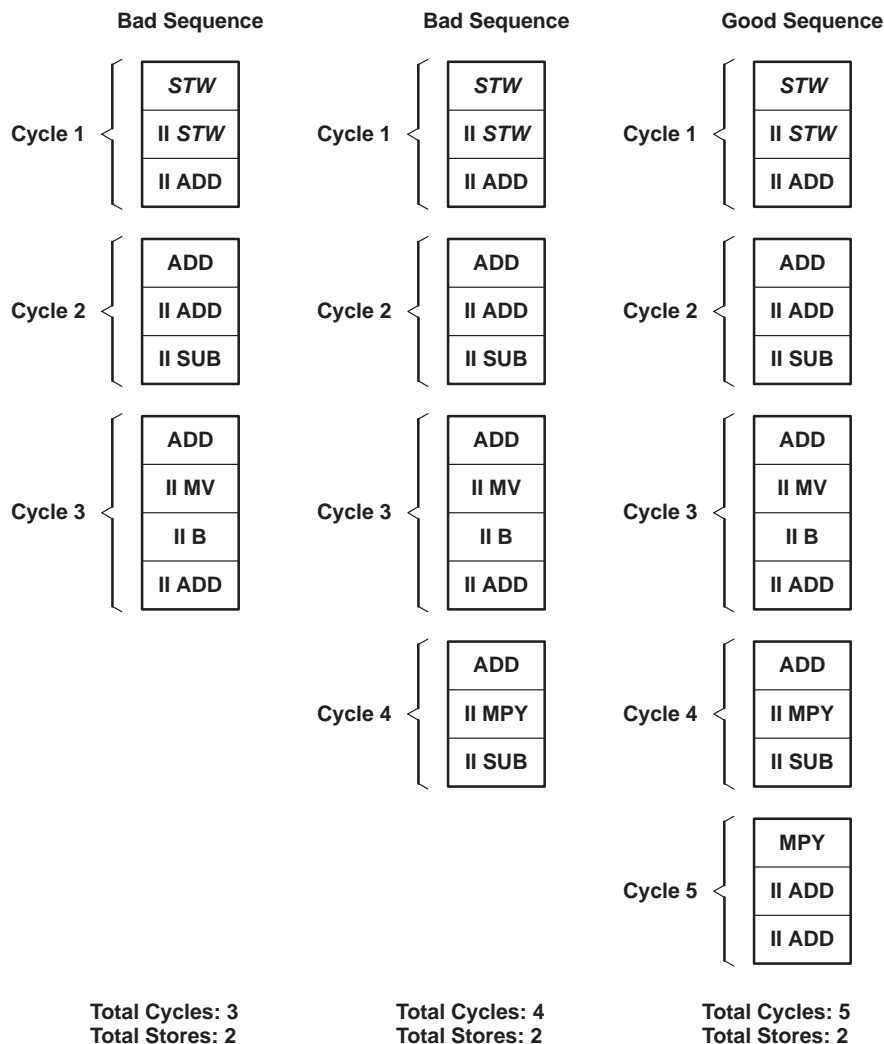
Figure 7. Pseudo Code Example With Parallel Stores (Criteria 2)

Figure 7 outlines this scenario. Note that the STW instruction represents a store of any word size (32-, 16-, or 8-bit).

In most looped code, more than one instruction would likely be executed on each cycle, i.e., instructions would be executed in parallel. In this case, as long as a store is one of the instructions being executed in parallel on a particular cycle, that cycle counts as a cycle on which a store occurs. Instructions with parallel bars (||) at the beginning of the line of assembly execute in parallel with instructions on the preceding line.

- A. Reduce the duration of the loop by breaking into smaller loops. If a particular problem loop has a length of 4 cycles (determined by looking at the software pipeline kernel in the assembly file), and the loop runs 200 times, then the total loop duration is ~800 cycles. If the deadline is 586 cycles, then loop could cause a problem (assuming the loop meets all the other criteria). The workaround is to break the loop into four smaller loops of 50 iterations each. Then any one loop will only run for 200 cycles allowing the EDMA transfer to complete between the smaller loops.

- B. Try to break criteria 2. The quickest way to do this is to turn off optimization for the file containing the problem loop (this is done in the File Specific Options for the file). Instead of using the compiler switch `-o3`, use the compiler switch `-o1` for the particular problem file. This will cause the problem loop to not be software pipelined and less likely to meet criteria 2. The downside to this fix is that all the loops in the particular file will be un-optimized, not just the problem loop.

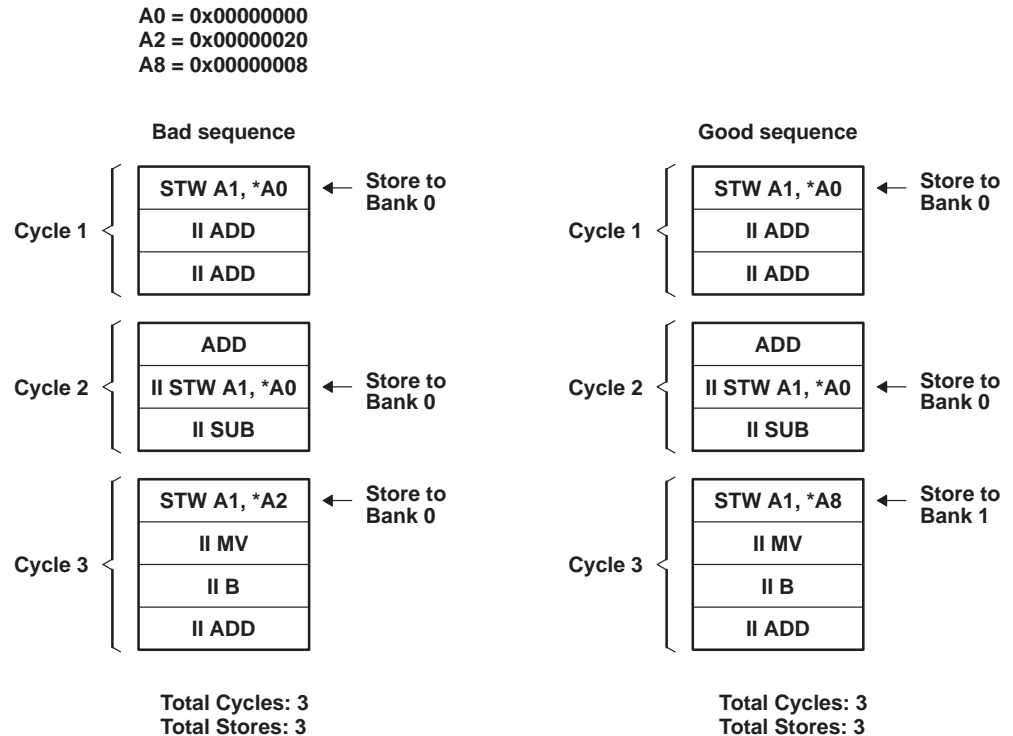
**Figure 8. Pseudo Code Example Stores to Specified Banks (Criteria 3)**

- All stores in the loop must be to the same bank of L2. If there are any stores to another bank, this will free the first bank long enough for the EDMA access to get in (see Figure 8).

In the case of two stores occurring on the same cycle, in parallel, the same rules apply. If both stores are to the same bank (and there are no other stores in the sequence to a different bank), then a problem may occur. If each of the parallel stores is to a different bank, then the problem cannot occur.

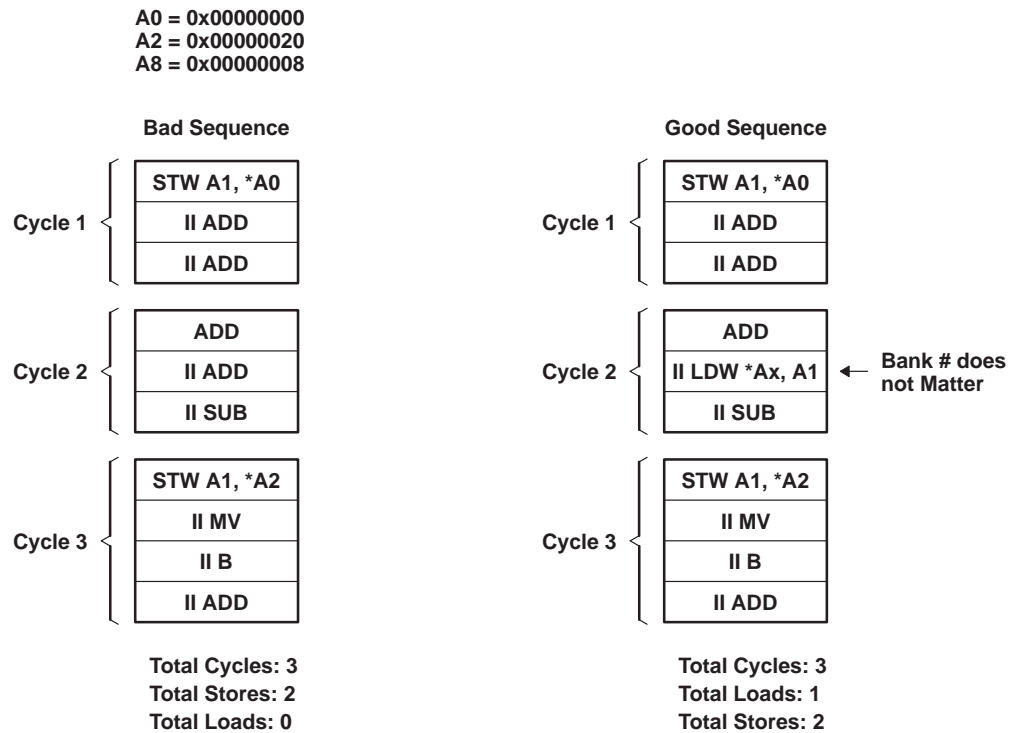
Figure 9. Pseudo Code Example Stores and Loads (Criteria 4)

A load from L2 provides enough of a gap to allow the EDMA to access L2. The good sequence would not cause a problem even if the load were executed in parallel with one of the stores, as long as the load occurred somewhere in the sequence. Notice that although the good sequence satisfies criteria 2 and 3, it would not cause a problem.

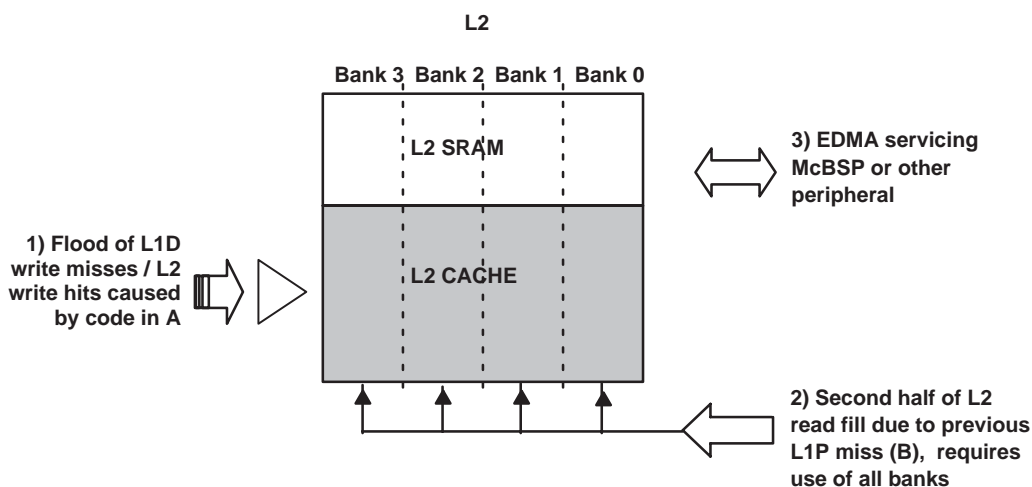
**Figure 10. Problem Scenario**

In this scenario, the next CPU fetch packet does not reside in either L1P or L2 cache; therefore, it causes an L1P and L2 miss. An L2 cache line (128 bytes, 4 fetch packets) must be fetched from external memory. The fetch from external memory is split into two requests (two halves) of 64 bytes, or two fetch packets each. In this document, the two halves are labeled A and B, respectively, as shown in Figure 10. The first half (A) to arrive in L2 is the half in which the missed fetch packet resides. This first half is immediately forwarded to L1P so that CPU can resume execution before the second half (B) is fetched from external memory. The second half of the L2 line (B) is to be fetched and written to L2 later.

The lockout condition occurs only when the second half (B) of the L2 cache line fill starts. When the B is ready, it attempts to write to L2. It will be unable to do so, however, because the line fill operation accesses all four banks of L2 whereas one bank is always busy servicing the higher priority L1D misses from the code in A. Thus, the line fill (B) cannot complete until the flood of writes from A has stopped. The line fill stays at the head of queue in the EDMA controller, so any other EDMA transfers that access L2 will also be blocked until the flood of stores has stopped *and* the L2 line fill (B) has completed.

The amount of time that an EDMA transfer is locked out of L2 is determined by the code running on the DSP (A), and ultimately by the amount of time that L1D write misses are happening in succession. When all of the conditions are met, the second half of the L2 line fill and the EDMA will be locked out of L2 as long as the flood of stores is sustained.

- Avoid the flood of L1D write misses. Pre-read all data locations prior to writing them. This will allocate them in L1D, preventing the L1D write misses from occurring. Recall that L1D read misses do not cause problems.
- Make sure that any algorithm or code segment that naturally produces a long string of writes inserts gaps in the write sequence such that writes occur at a frequency slower than 1 write miss every other cycle. The term "long" is based on the system requirements. Gaps in the L1D write misses means that the second half of the L2 read fill is given a chance to access L2.

- Run the algorithm or code segment that contains A from internal SRAM. There will not be L2 code read fill (A or B) coming into L2. The simulator can be used to detect such code segment. See the C6x1x Simulator section below for details.
- Ensure the problematic segment of algorithm or code is in cache. This can be accomplished by issuing any CPU read/load instruction from the beginning of the problematic code segment in external memory, that will cause both L1D and L2 miss. Assuming the code segment is not yet in L1/L2 cache, Performing CPU load instruction generates an L1D request, and CPU stalls until the code missed and data is returned from L2. After the load instruction, code segment will reside in the L2 cache, and an L2 read fill due to L1P miss will not occur.
