STM32G471xx/473xx/474xx/483xx/484xx device errata

Applicability

This document applies to the part numbers of STM32G471xx/473xx/474xx/483xx/484xx devices and the device variants as stated in this page.

It gives a summary and a description of the device errata, with respect to the device datasheet and reference manual RM0440.

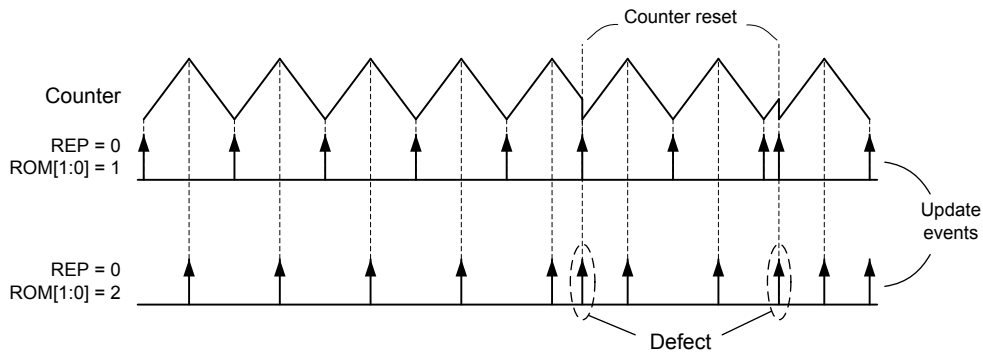
In up-down counting mode, the value 2 in the roll-over mode bitfield ROM[1:0] sets the corresponding roll-over event to occur when the counter rolls over the crest, which then induces timer register update, based on other settings. However, with ROM[1:0] at 2, the register update is also unduly triggered upon the counter reset, as illustrated:

The defect impacts the timer x operation with the following settings:

- TxREPU = 1, for the update when the timer x repetition counter reaches zero (in this case, the spurious roll-over event at the counter reset propagates to register update event while not decrementing the repetition counter)
- TxRSTU = 1, for the update upon timer x reset
- RSYNCU = 1, for the update re-synchronized with the counter roll-over event

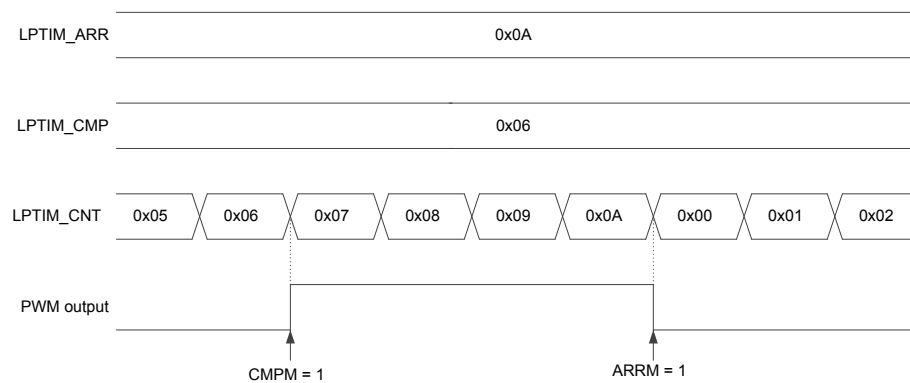
Consequently, it is not possible to generate PWM with a duty cycle of 0% or 100%.

The following waveform gives the example of PWM output mode and the effect of the delay:

Set the compare value to the desired value minus 1. For instance in order to generate a compare match when LPTM_CNT = 0x08, set the compare value to 0x07.
