## PRODUCT CHANGE NOTIFICATION

**Product Identification:** Bel 0863, 0864, 0873 2x4, 2x6, 2x8 ICMs

**PCN Number:** PC2190135

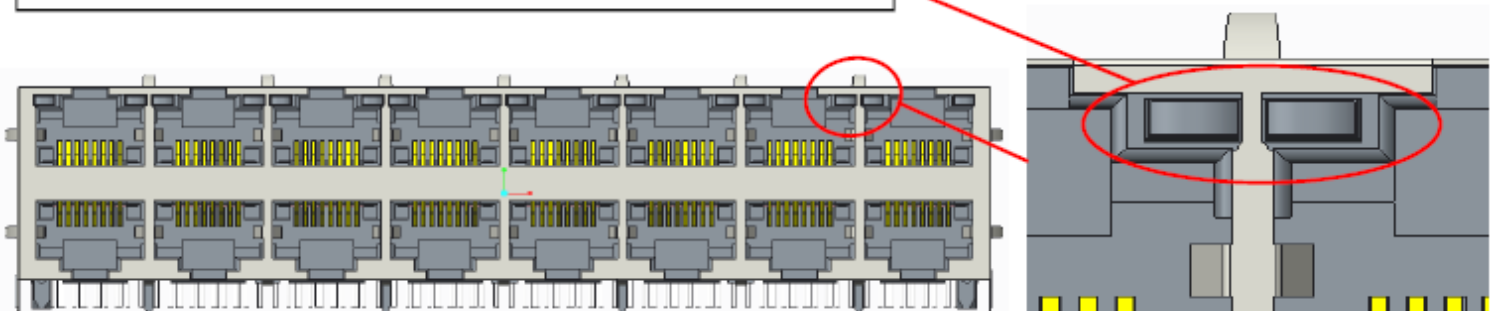
New finished goods: remove the LED window features.

**Description of the Change (s):** To resolve the assembly issue and deformation of the shield around the light-pipe, the thin, shield window frames around the inside and bottom of the light-pipe will be removed. By removing these thin metal pieces, the limited gap issue will be resolved and there will not be a concern for shield deformation. Please see the details below.
